QA-326

Harry Chambers House
101 South Liberty Street
Centreville
Private

INVENTORY FORM FOR STATE HISTORIC SITES SURVEY

Harry Chambers House

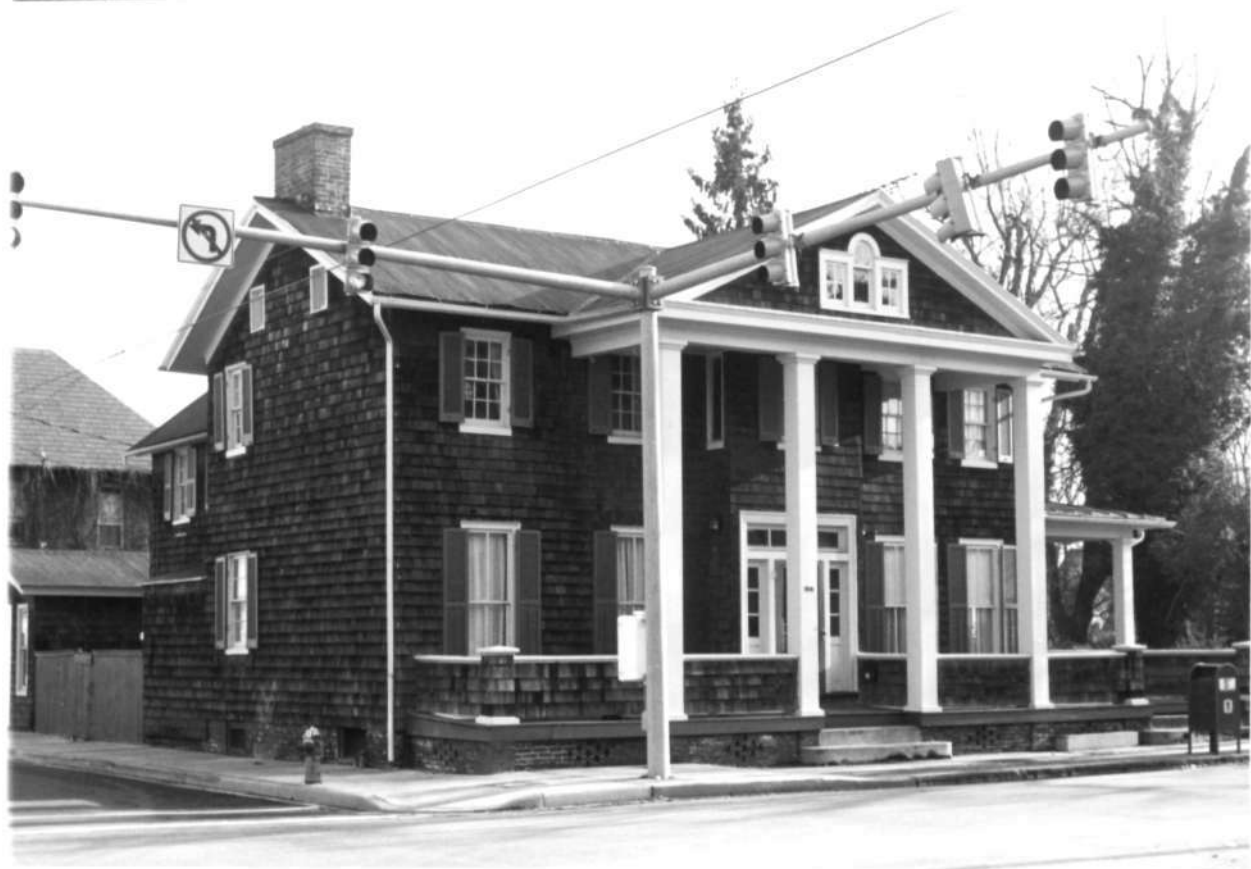
QA-326 Chambers House
101 South Liberty Street
Centreville, Maryland
Orlando Ridout V 1981
Front facade from Northwest

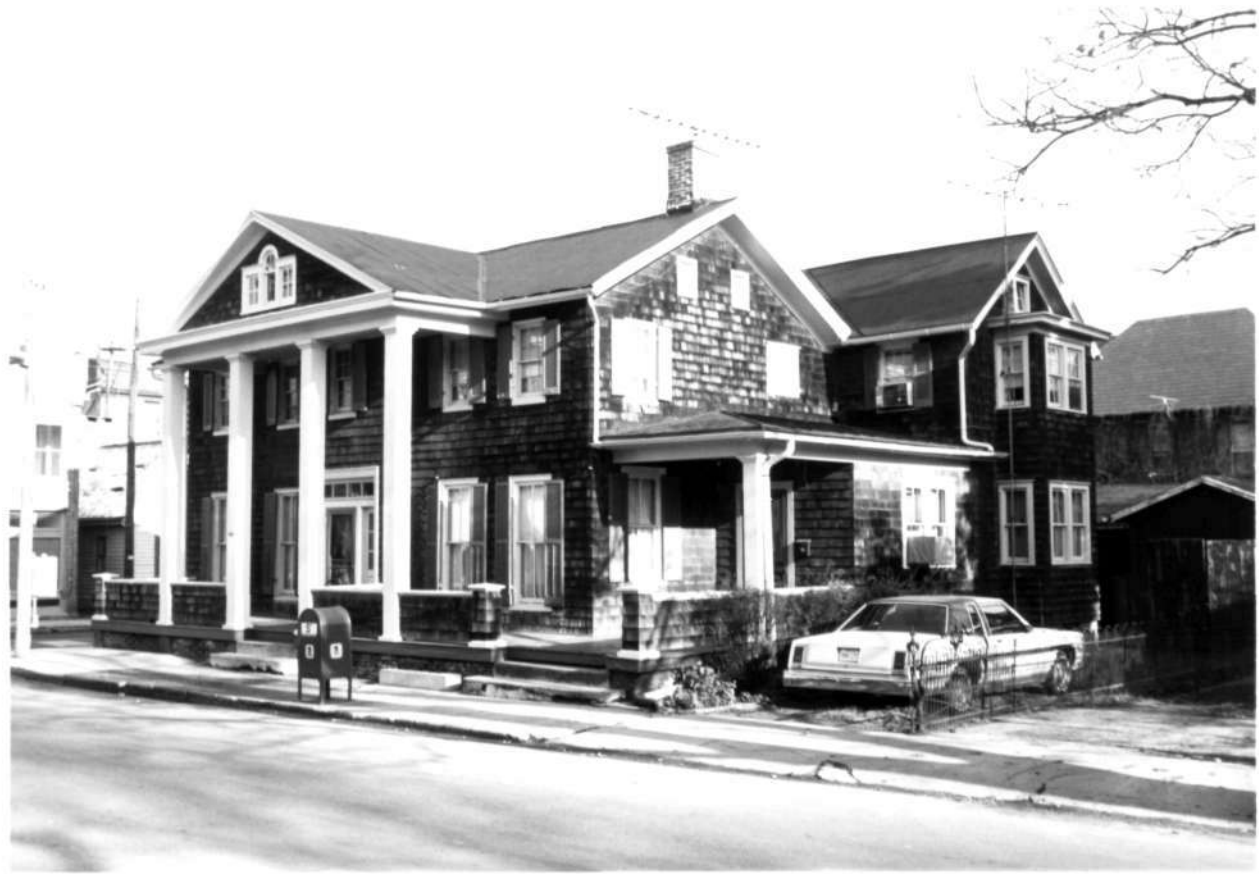
QA-326 Chambers House
101 South Liberty St.
Centreville, Maryland
Orlando Ridout V
Front facade from Southwest
